Manhole Inspection Summary

Manhole # S41AA_065MH

Insp Date: 11/11/08 11:46 AM

Location Address: **1401 e monument st**

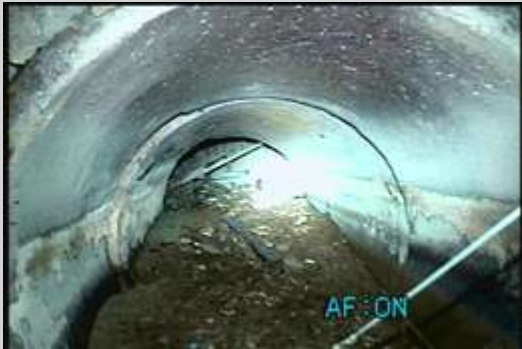
12 O'Clock Outflow

15 in. Circular Gravity Sewer
Pipe Out @ 12 O'Clock

Deposits: ☒ None ☐ Mud ☐ Sludge ☐ Debris ☐ Grease

Infiltration: **None** Pipe Seal Cond: **Unknown**

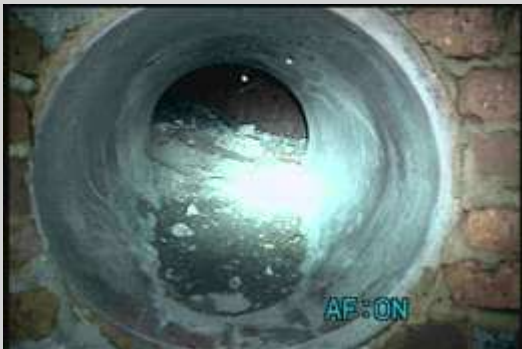
5 O'Clock Inflow

15 in. Circular Gravity Sewer
Pipe In @ 5 O'Clock

Deposits: ☒ None ☐ Mud ☐ Sludge ☐ Debris ☐ Grease

Infiltration: **None** Pipe Seal Cond: **Unknown**

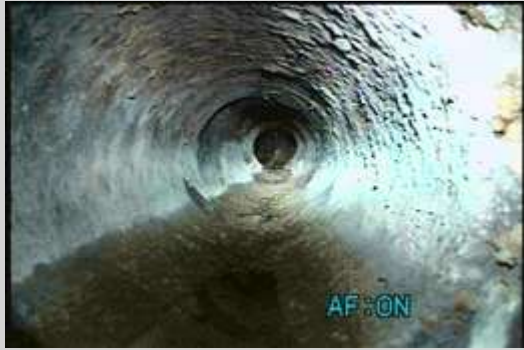
8 O'Clock Inflow

12 in. Circular Gravity Sewer
Pipe In @ 8 O'Clock

Infiltration: None
